Wind turbine plant of Nadachi

North-West Coast of Japan

Damages on a wind turbine due to lightning strikes.

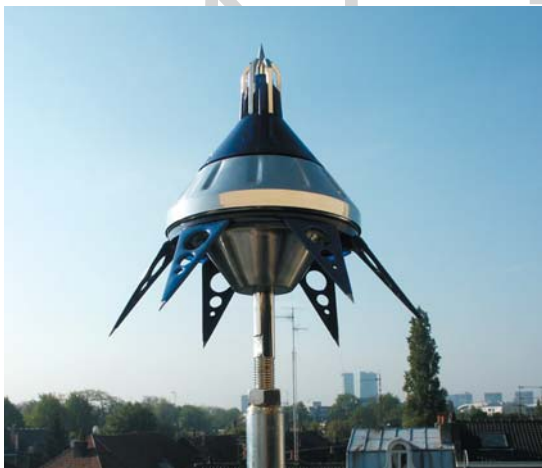
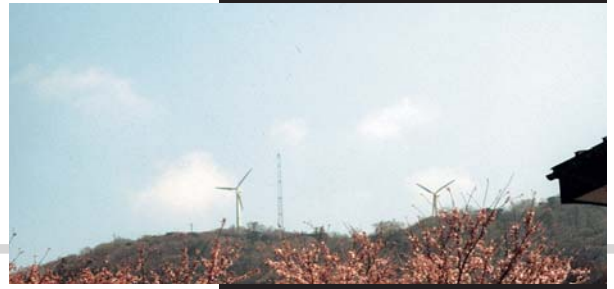
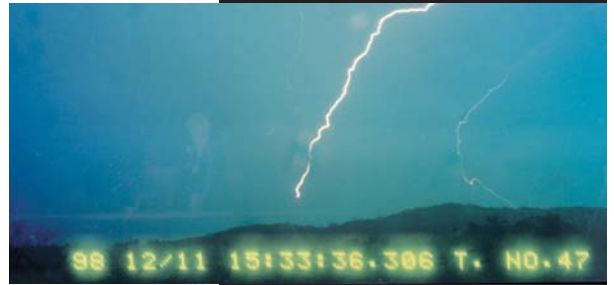
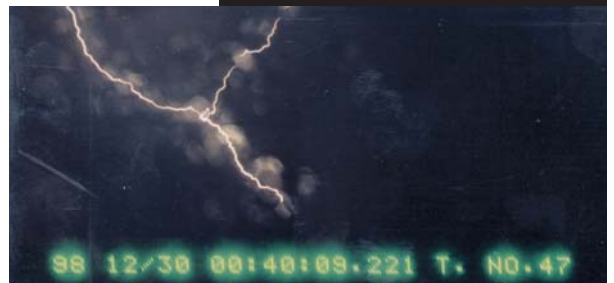
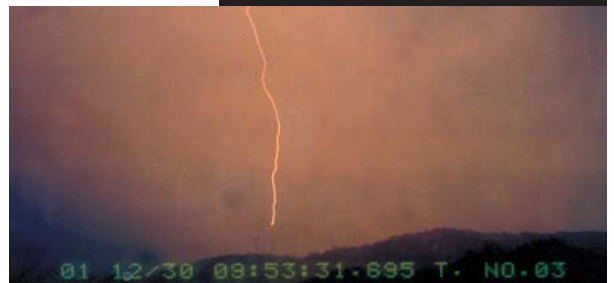
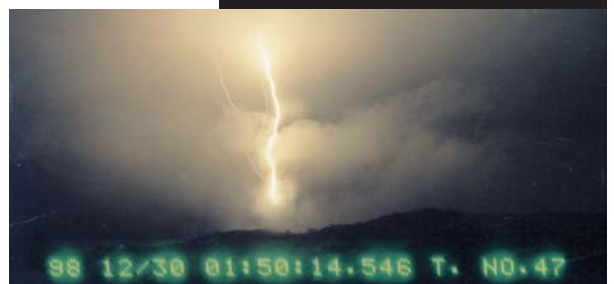
This report presents the results of more than 4 years of monitoring from 1st quarter 1998 to 1st quarter of 2002 with dozen of exposures showing cloud/ground flashes. A few example of pictures are presented in this brochure.

In 1998, of the 32 impacts - most of which were of the upward type - 29 were caught by the ESE protection system, thereby avoiding considerable damage to the generators and auxiliary equipment. 2 impacted the turbine closest to the protection system and one impacted the turbine farther away. However, the three probably low intensity impacts that hit the generators only cause traces at the surface of the blades, but no structural damages to the turbines.

12 lightning strikes have been recorded on the site from December 14 to December 30 with an impressive 100% success rate for the Prevectron Millenium (the 12 strikes were caught by the ESE air terminal).
